JPL MARS OBSERVER IN-FLIGHT ANOMALY INVESTIGATION

(with emphasis on attitude control aspects)

BACKGROUND

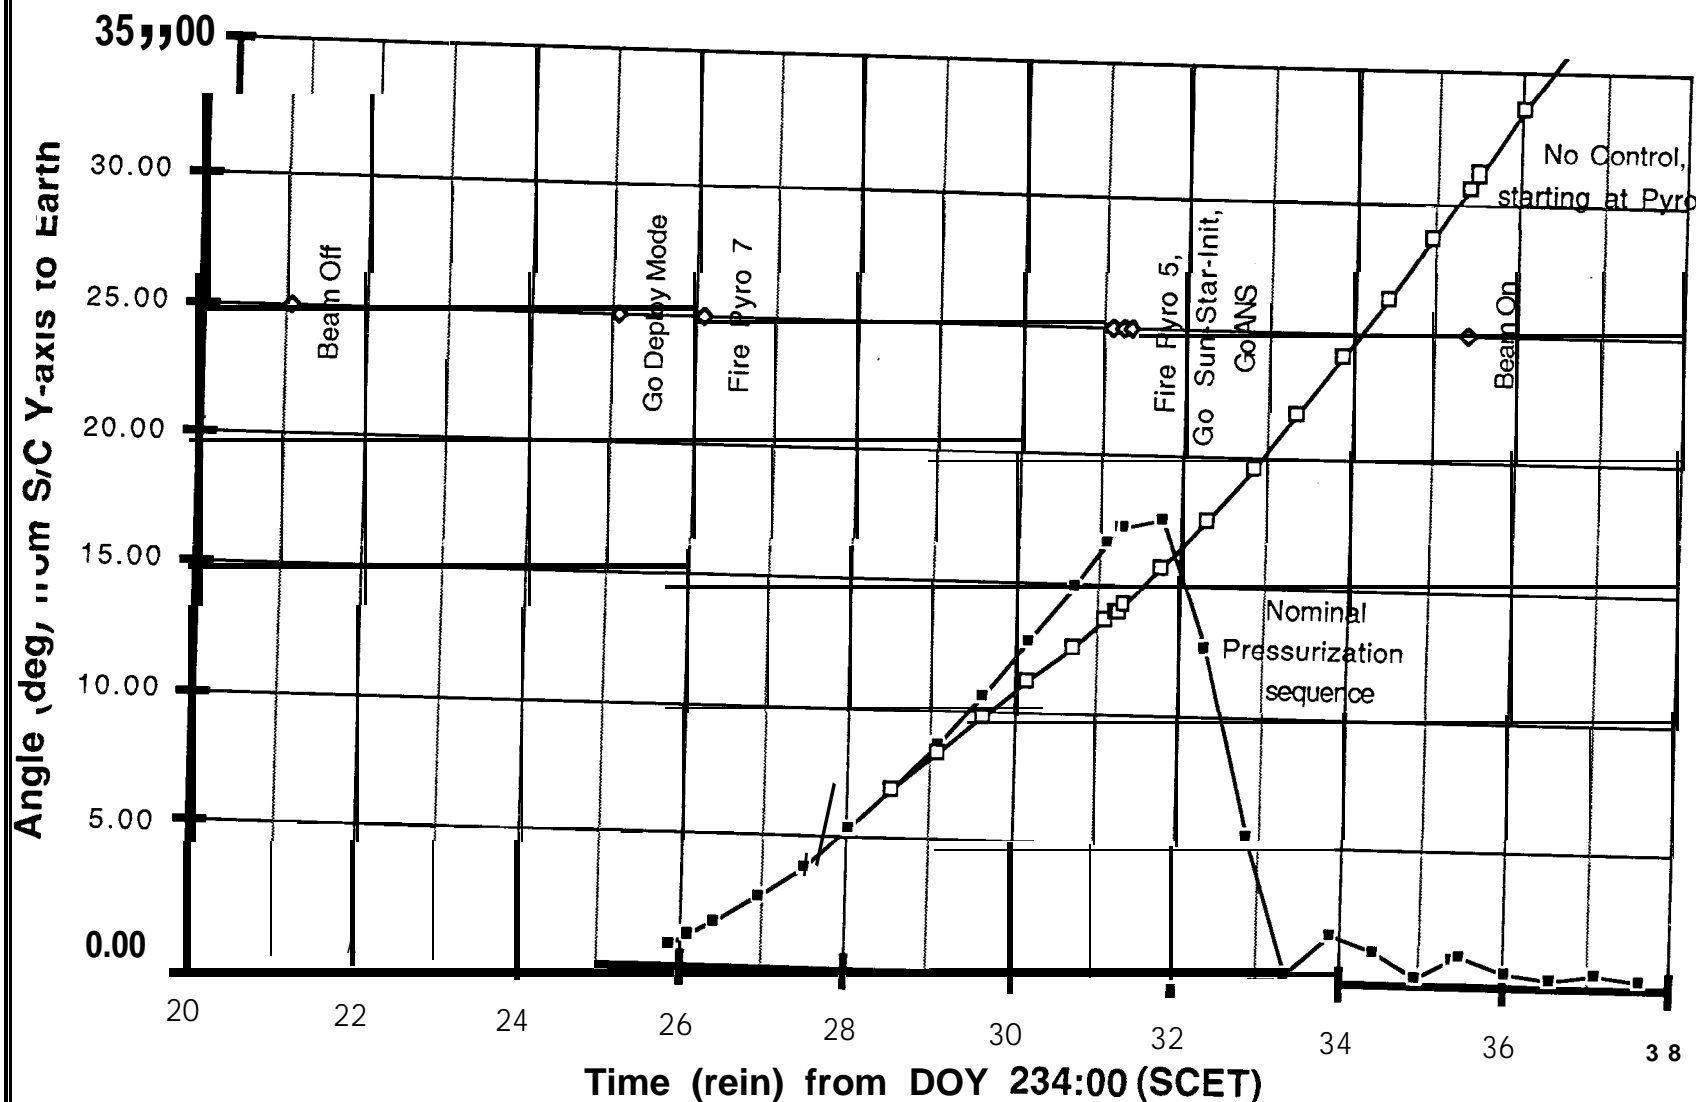
HGA Offset from Earthline During Pressurization

On August 21, 1993, Mars Observer was executing a sequence to pressurize the propulsion tanks in preparation for Mars Orbit Insertion three days later. As part of that sequence, the transmitter was turned off, and no signal has been detected since.

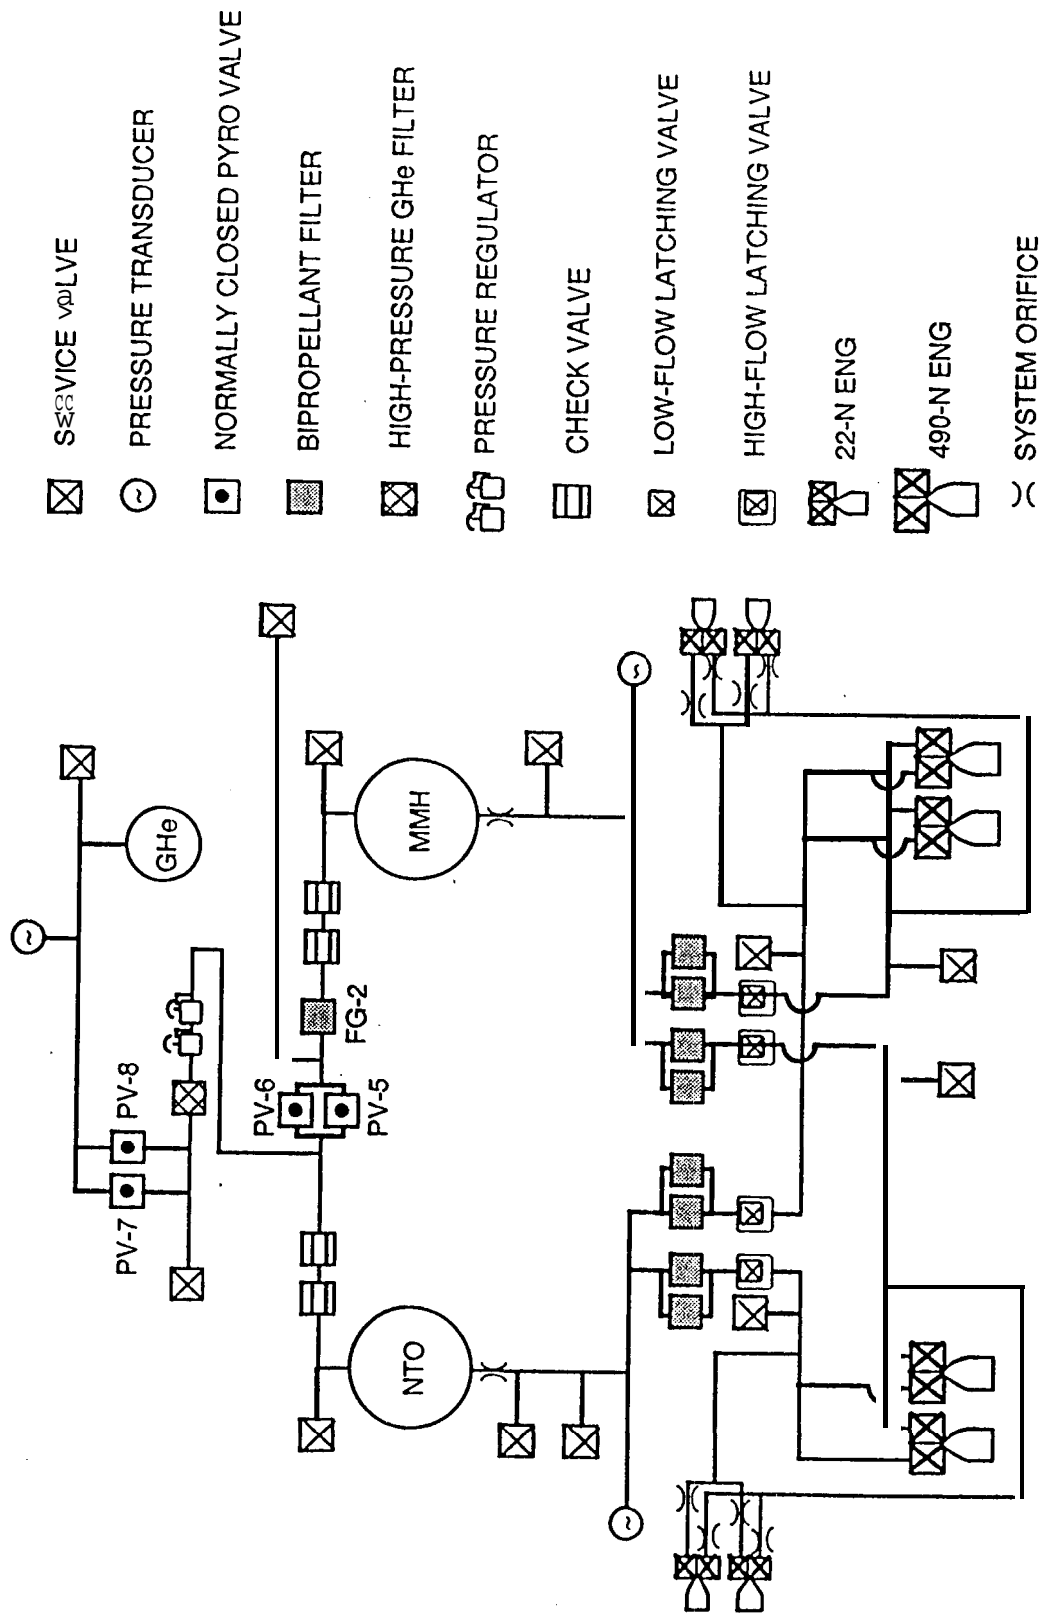
Bipropellant Elements

Scenario: Temperature gradients and slow diffusion through two series check valves allow ≤ 2 g of NTO to condense upstream of Pyro valve-5. When PV-5 is opened, some of this NTO is forced into the MMH line and reacts abruptly with the MMH. Peak pressures cause the line to bulge and develop a longitudinal crack. The helium pressurant vents out over 30-60 minutes, followed by the ullage He in the MMH tank and -500 kg of MMH. The gas release causes the spacecraft to spin up to ~10 degrees per second which might preclude detecting the downlink and run down the batteries. For other assumptions, the spacecraft might regain attitude control and/or a downlink might be detected.

- (1) Tests show that transport past check valves will occur**
- (2) NTO will react with MMH**
- (3) Analysis and tests show that reaction can cause significant pressure pulse (1 observed in 13 tests)**
- (4) Causally related to sequence**

- (1) 2 g of NTO requires double check-valve failure; non-failure case yields <0.5 g**
- (2) Tests produced no significant pressure rise with < 2 g of NTO**
- (3) Downlink might have been detected in significant subset of cases (attitude stabilizes or HGA sweeps past Earth)**

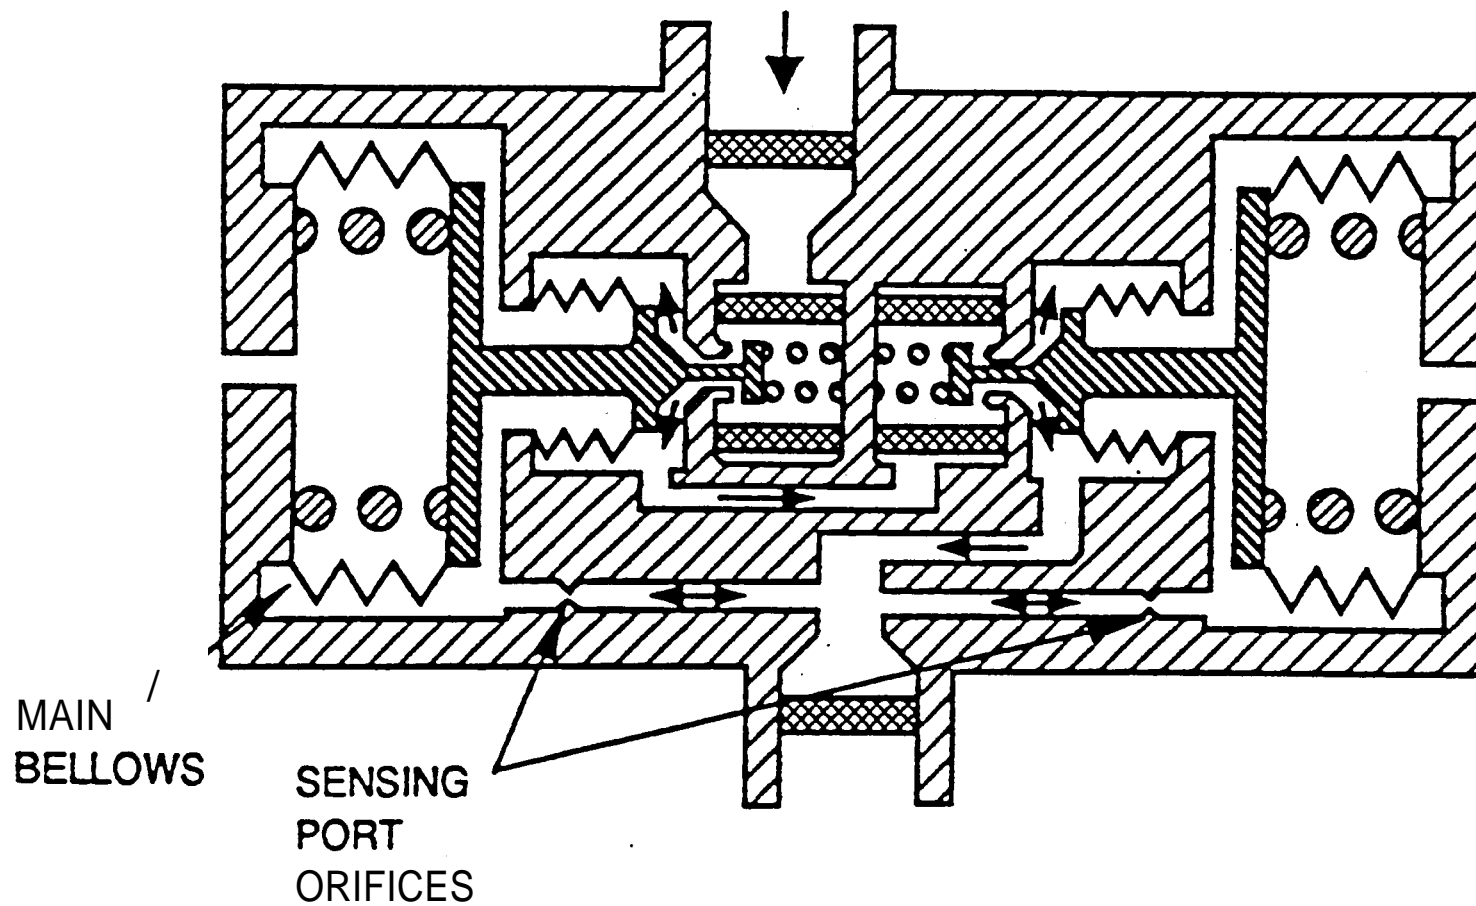
Regulator Schematic

Scenario: The series-redundant regulator has some contamination in the vicinity of the 0.005-inch diameter sensing ports. NTO vapor diffuses past the check valves and reacts with contaminants causing a gummy material that blocks the sensing ports. Pyro valve-7 (high-pressure) is opened to pressurize the NTO tank. The regulator ports become blocked and gas flow continues until the NTO tank bursts 30 to 200 seconds later. Tank burst releases -6×10^5 Joules of energy. The spacecraft experiences immediate critical physical damage.

- (1) Vapor leakage was demonstrated in tests
- (2) Some "clean" check valves used for ground tests were contaminated
- (3) Shuttle (similar regulator) had a stuck-open failure
- (4) Tank would burst well before downlink turned on
- (5) Causally related to sequence

- (1) Long-term exposure to NTO vapor alone is not a problem on Shuttle
- (2) No direct evidence of regulator contamination
- (3) Both sensing ports must be blocked

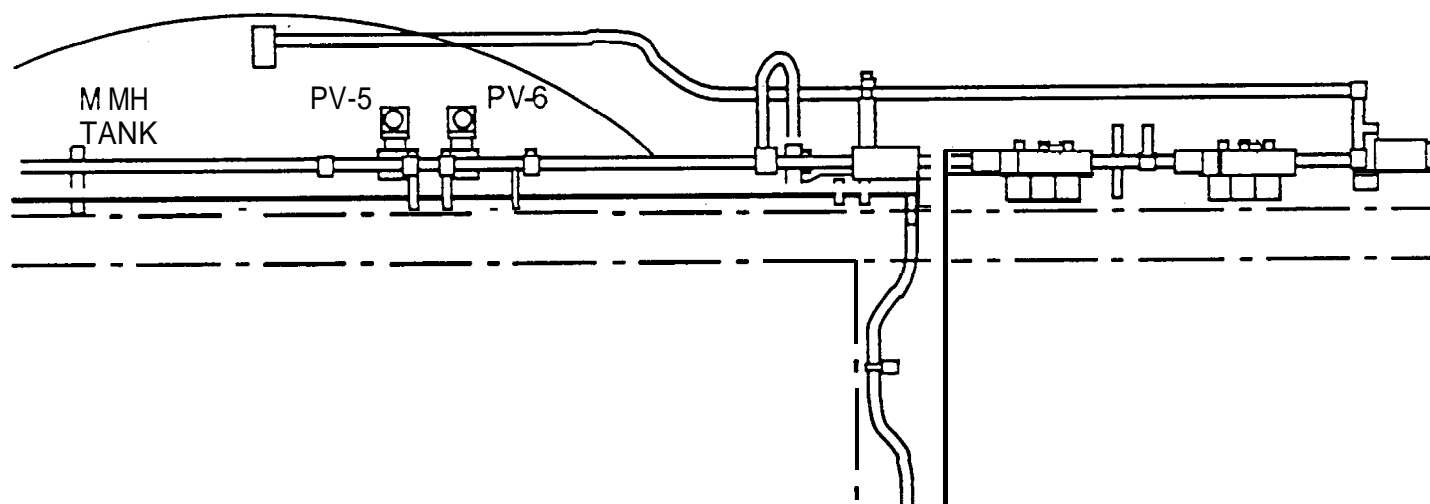
Relation of Pyro Valves to MMH Tank

Scenario: Pyro valve-5 was fired during the planned pressurization sequence. The inboard (not electrically fired) 15-gram NASA Standard Initiator (NSI) is expelled from the titanium pyro valve body by the high internal pressure pulse at 200 meters per second and strikes the MMH tank. The tank bursts and breaks into fragments and releases $\approx 10^5$ Joules of energy. The spacecraft suffers immediate critical physical damage.

- (1) ESA experienced an initiator expulsion on 3 of 3 Cluster S/C ground tests and 1 of 2 bomb tests
- (2) Examination of test-fired MO valves shows thread erosion and chemical attack
- (3) Analysis shows thread design to be marginal
- (4) Causally related to sequence

- (1) ESA initiators were not NSIS -- gave 10-15% higher pressures and faster rise time (but met NSI specification)
- (2) No identical titanium pyro valves with one sympathetically fired NSI are known to have expelled a NSI (0 out of 5 known firings)
- (3) Only the electrically fired ESA initiators were expelled (outboard on MO)

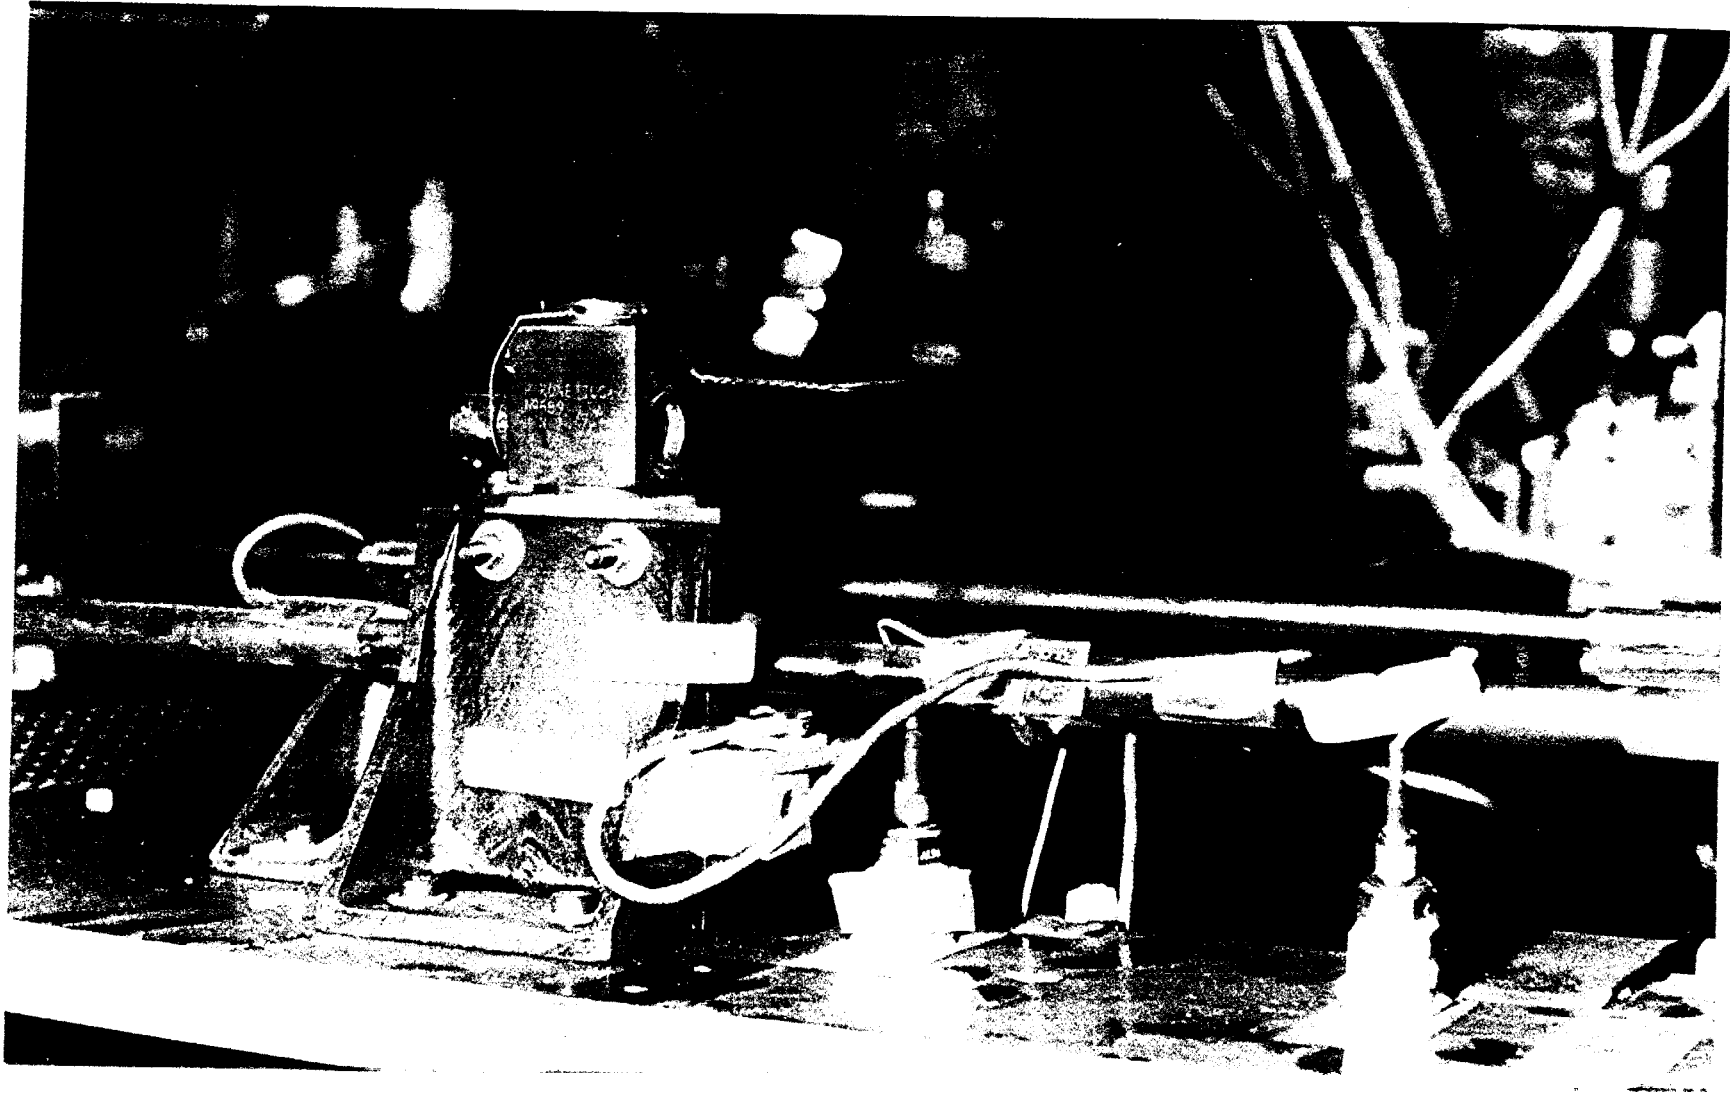
FIRST FIRING TEST (PV5.0)

CFRP FACE SHEET UNDER VALVE BRACKET WAS CRACKED

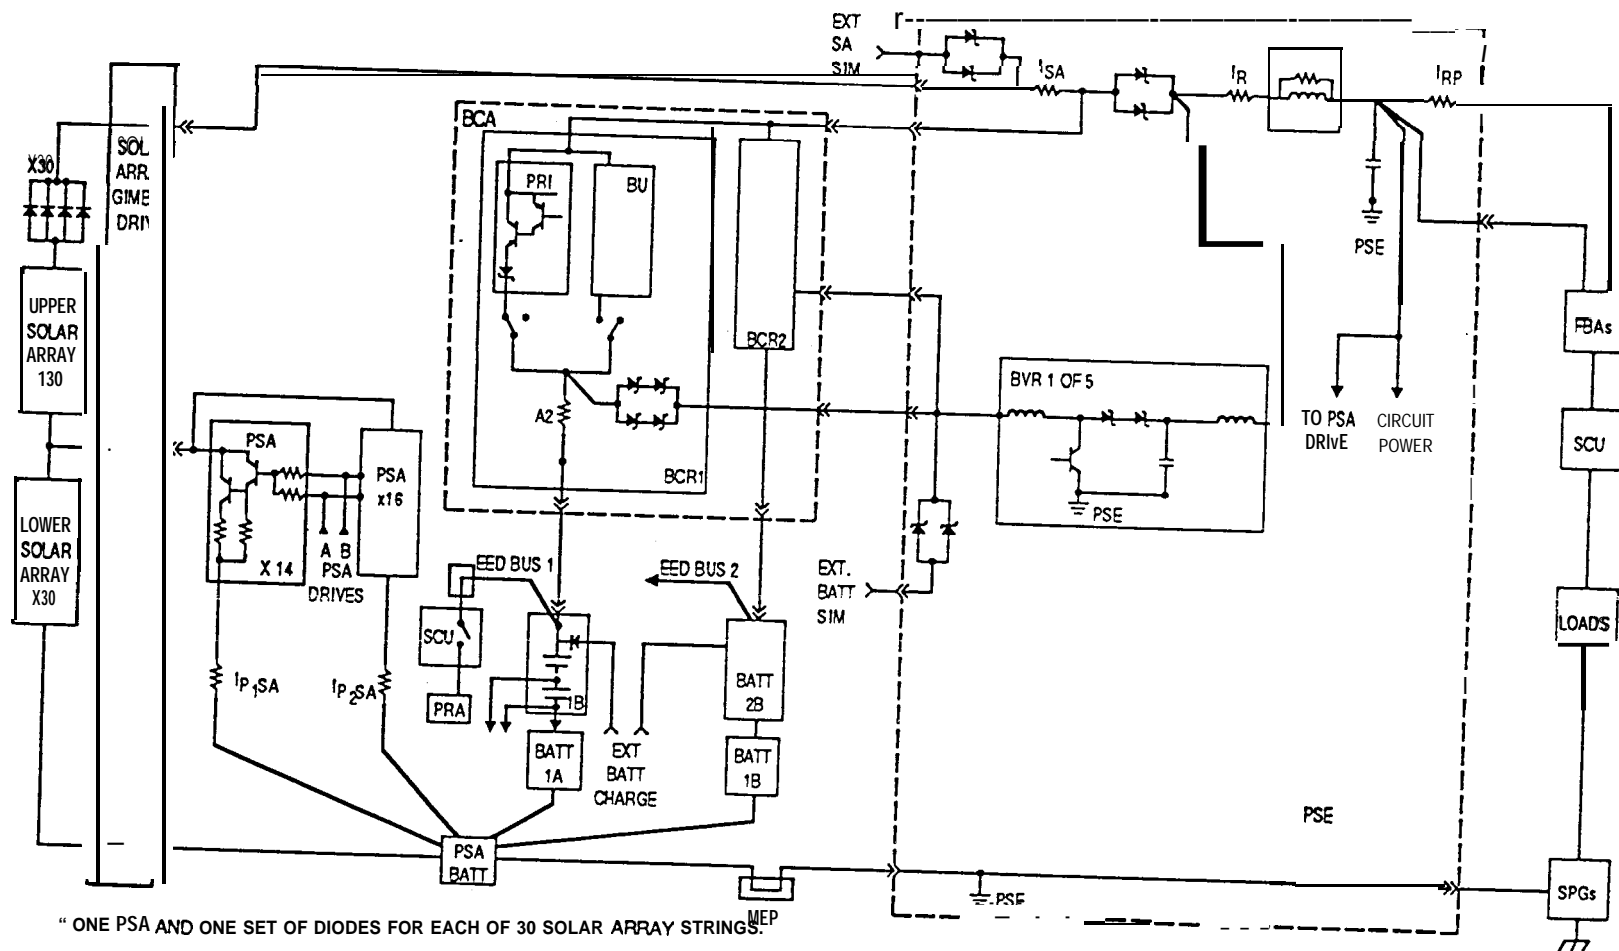
Unfused Power Schematic

Scenario: The design of the power subsystem allows a single high-side short to chassis in selected parts of the power system to fail the spacecraft. In many places, a thin electrical insulator (6 mils) is the only protection. Workmanship problems, such as burrs, solder balls, debris, tolerance buildup, over-torquing, and improper assembly, could create vulnerable areas. Thermal cycling works the critical areas. After -400 thermal cycles of -15°C, a small thermal change from turning off the RPA (~4°C) causes a short to form. Spacecraft power bus voltage drops and the spacecraft stops functioning.

- (1) Similar failures have occurred in flight (NOAA-1 had a power failure within 1 hour of the MO failure. Mariner II)
- (2) Disassembly of spare power system showed poor workmanship (improperly installed isolation bushings, excessive electrically conductive thermal adhesive, and contamination)
- (3) Tests show that initial shorts will evolve into permanent, hard shorts (6 out of 9 trials)

- (1) Temperature cycle was small giving a weak tie to pressurization sequence ("straw").

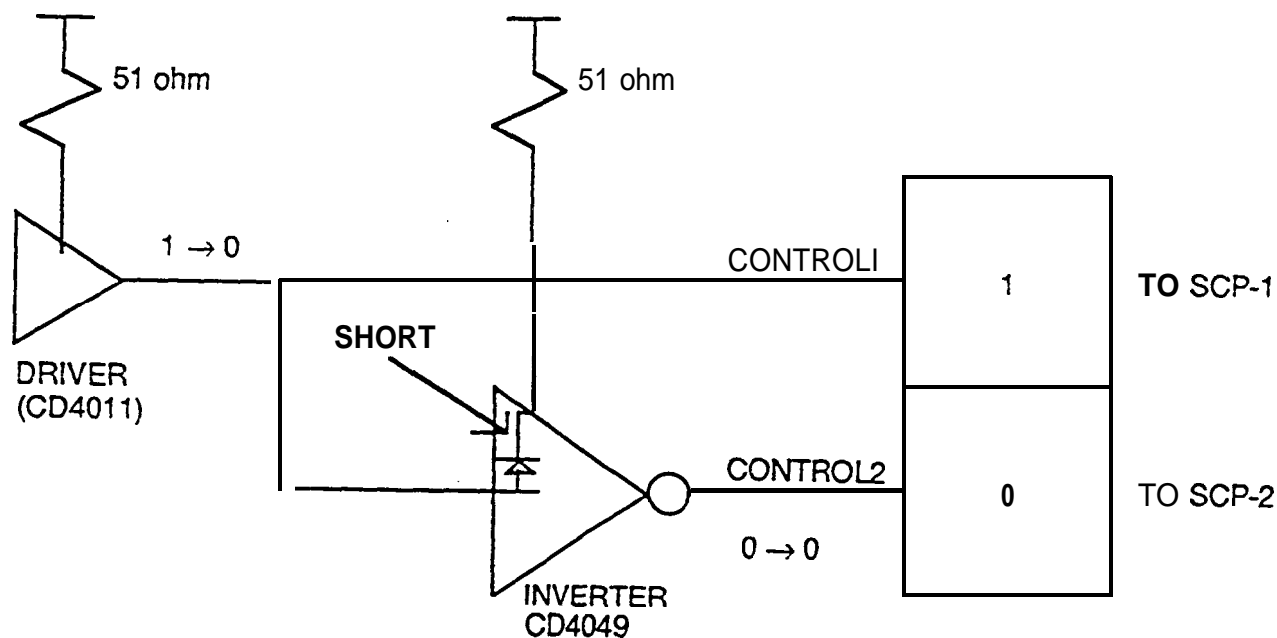
SCP In Control

Scenario: Firing of Pyro valve-7 or -5 causes a high return current through the chassis (frame) of the spacecraft. The return current loops couple with another circuit which latches up one of several electronic parts. The part failure precludes the spacecraft computer from controlling the spacecraft. The spacecraft transmitter does not come on, the s/c tumbles, and the batteries run down after ~22 hours.

1. If latch-up occurs, the top protection diode of the inverter is shorted to 5 V.
2. V_{CC} drops to 5 V.
3. The output is now at 5 V (indeterminant—interpreted as "O" by control 2).
4. Pulls output of driver to 5 V (indeterminant—interpreted as "O" by control 1).
5. Therefore, neither SCP-1 nor SCP-2 is active.

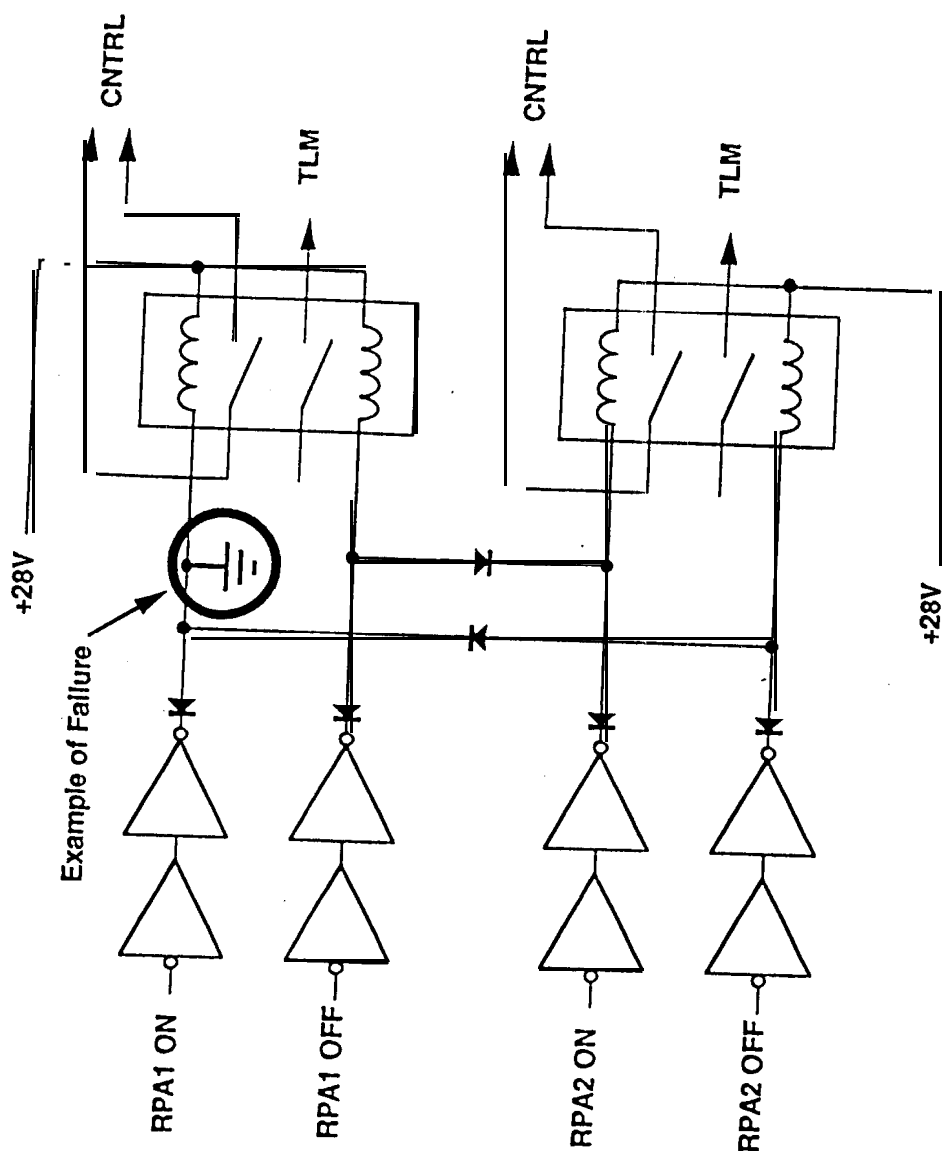
SCU Interlock for RPA: Functional Schematic

Scenario: The circuit that controls RPA 2 beam-on (active transmitter) fails high at any time after August 2nd (can also be caused by Hypothesis C5 pyro current -- induced latch-up). The cathode heater turned off during pressurization sequence. The heater is turned on again but RPA 2 beam cannot be turned on due to internal RPA logic which requires a low-to-high signal transition to turn on beam. RPA 1 cannot be turned on either because of SCU interlock circuit (to prevent both transmitters from being on simultaneously). Can also occur if RPA 1 beam-on fails high during pressurization sequence.

Comment: In this scenario, the spacecraft is alive and well in Mars orbit. The MBR experiment can resolve this scenario. A positive signal detection would mean this hypothesis is the single Probable Cause. A negative result is an argument against. Results will not be definitive until May 1994. If a positive detection, there may be a way to clear the latched-up part by intentionally depleting the battery and forcing a POR.
